**WELL ASSESSMENT REPORT
CEDAR CHEMICAL COMPANY
WEST HELENA, ARKANSAS**

Revision: 0

August 6, 2007

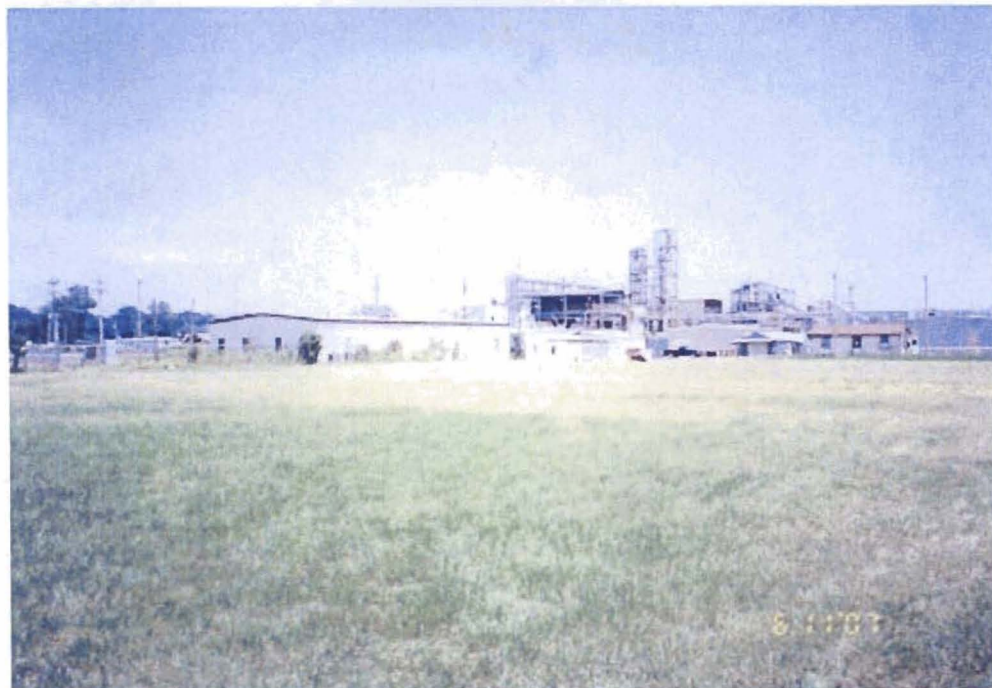
Photo 25: View looking northeast from well 2MW-5.

2MW-4	42.81	39.92	201.1	39.92	161.18	1357	UPPER	Good condition
2MW-5	40.17	38.01	199.9	38.01	161.89	1344	UPPER	Good condition; no lock
2MW-6	39.7	36.61	198.47	36.61	161.86	1018	UPPER	Good condition-cap ok
2MW-7	>100	37.16	198.7	37.16	161.54	1016	LOWER	Good condition-cap ok
4MW-1	36.79	36.03	197.69	36.03	161.66	1256	UPPER	Needs new expander cap; Flush
4MW-2	NF	NF	198.01	NF	NF	TNA	UPPER	Could not find
4MW-3	44.17	40.27	200.91	40.27	160.64	TNA	UPPER	Good condition
4MW-4	>150	44.96	202.04	41.96	160.08	1137	LOWER	Needs new expander cap
EMW-1	37.45	21.95	198.23	21.95	176.28	1007	UPPER	Good condition-needs new expander cap; TCE and DTW not reliable as of 2001 sampling
EMW-2	34.85	DRY	199.87	34.85	165.02	TNA	UPPER	Mud in bottom; Dry
EMW-3	37.15	DRY	199.31	37.15	162.16	TNA	UPPER	Outer casing bent; Dry; Soft bottom-silt?
EMW-4	35.68	18.47	198.13	18.47	179.66	1032	UPPER	Outer casing cover hinge broken; TCE and DTW data not reliable as of 2001 sampling
